**ERGO SOLAR PHASE 2:
Up to 40MW PV facility on the farm Witpoortje 117, Withok
131 and Withok Estates, Ekurhuleni Municipality, Gauteng**

**Terrestrial Biodiversity (Vegetation) Assessment
and plant Species Compliance Statement**

Date: June 2022

Updated with Optimized layout in August 2022

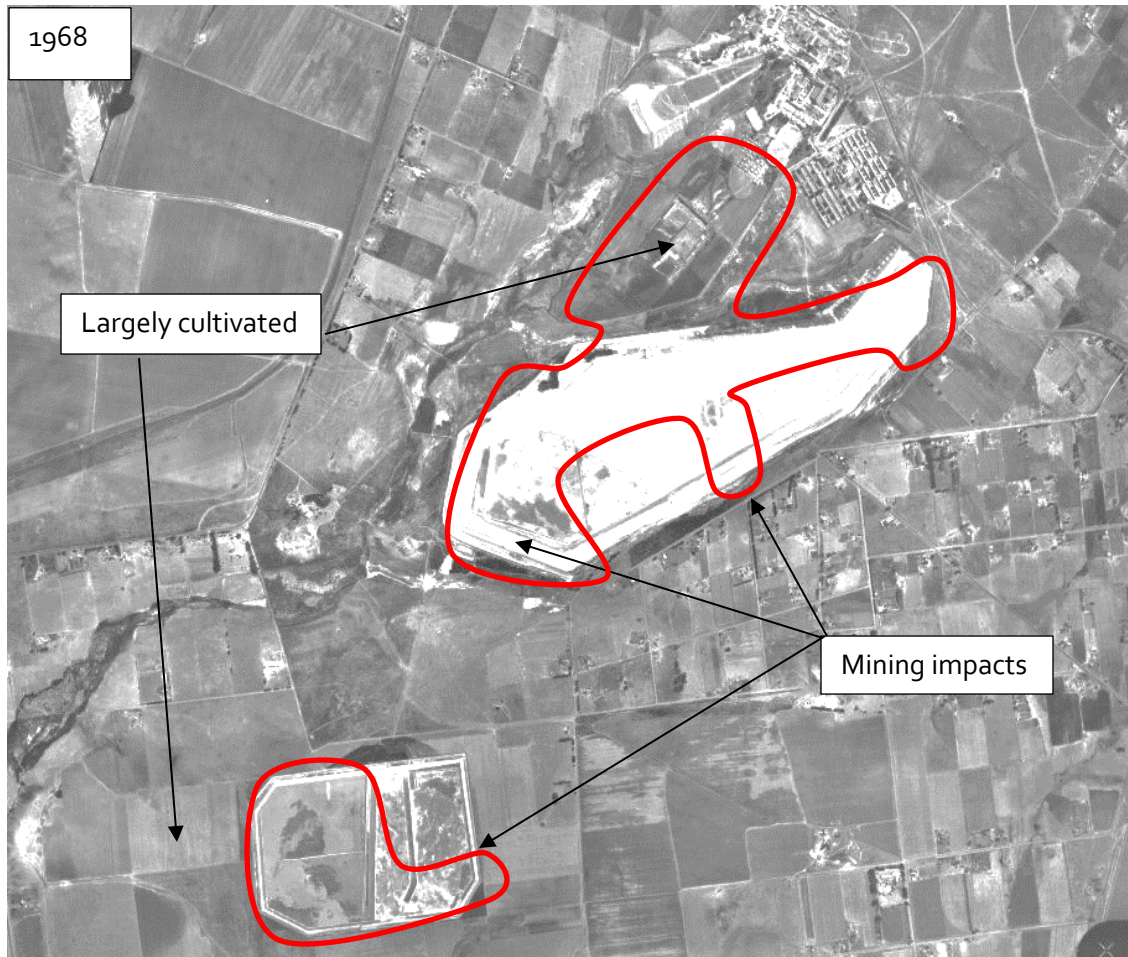
Figure 9: Historical aerial imagery dated 1968 (Chief Directorate National Geospatial Information Geospatial Portal) showing the mined and cultivated land within the site (estimated in red polygons)

Figures 9 and 10 show the mining activities and cultivation on the estimated site area in the years 1968 and 1996. Figure 11 shows the site in the year 2002 with mining and cultivation remaining main forces behind land cover change. In Figure 12, the most recent satellite imagery (Google Earth 2021), the slimes dams are rehabilitated and the historically cultivated areas fallow. There has been a return of some indigenous plant species and ecological function over the ten years. However, most of the vegetation in a secondary state.

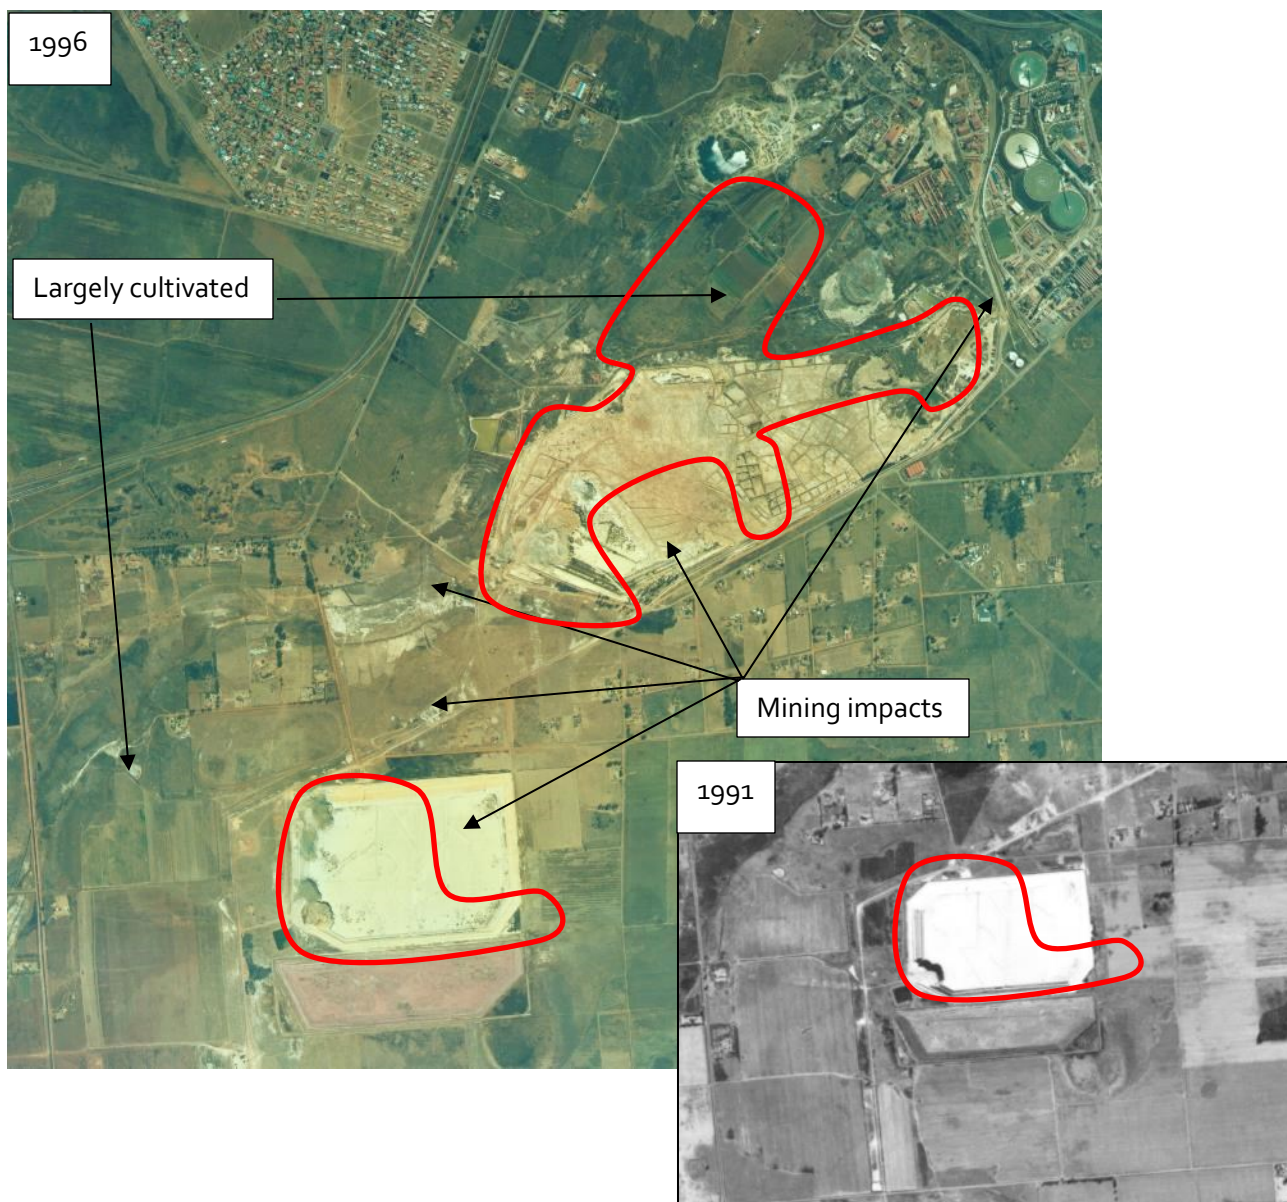
Figure 10: Historical aerial imagery dated 1996 (Chief Directorate National Geospatial Information Geospatial Portal) showing the increase in mining and associated development impacts. The insert dates to 1991 and shows cultivation south and south-west of the tailings dam

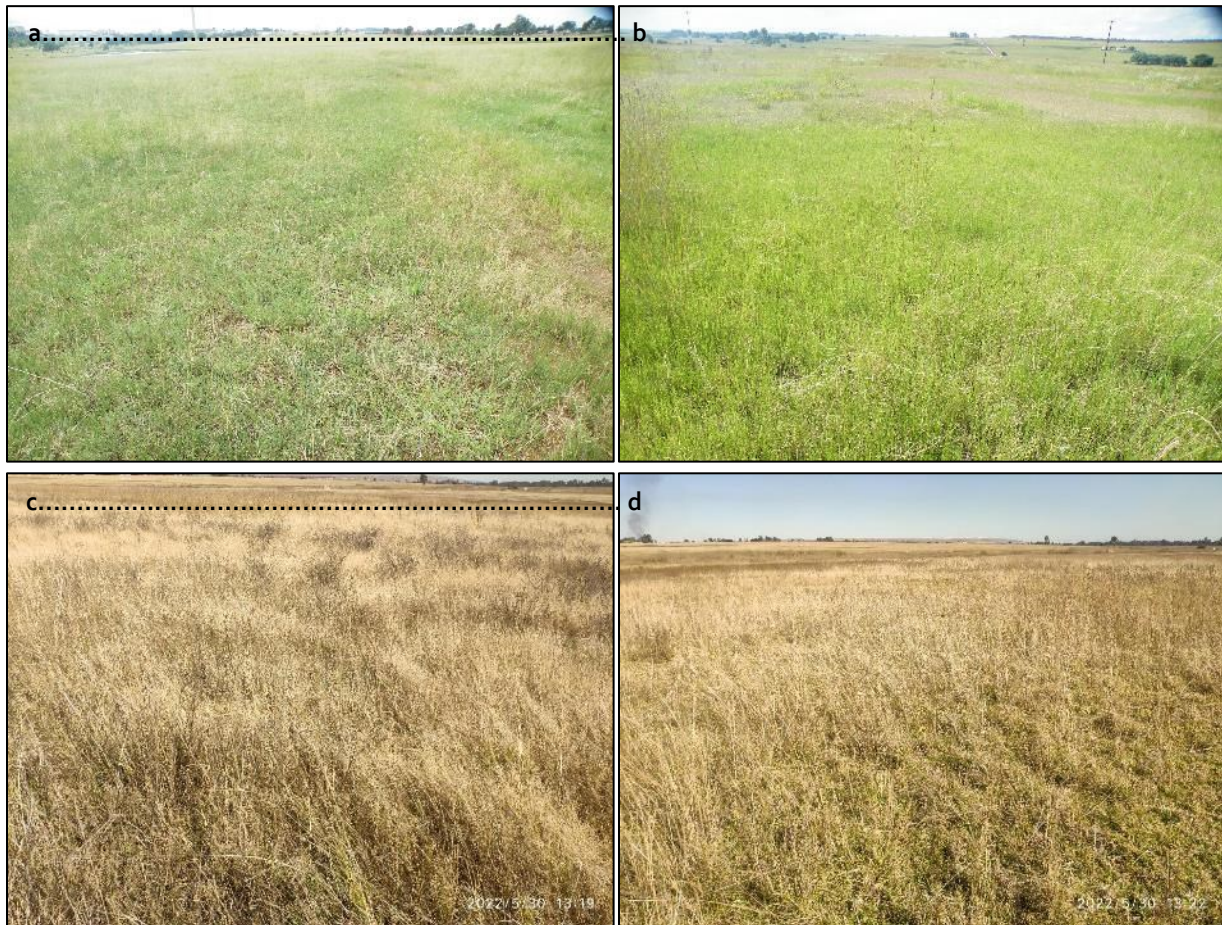
Photo plate 1: Secondary *Cynodon* and *Eragrostis* dominated grassland on the preferred sites. Image a&b) shows the secondary grassland on Prt 183 of the Farm Witpoortje in February 2021 (rehabilitated slimes dam). Images c&d) shows the grassland on Prt 272 of the farm Witpoortje in May 2022 (fallow lands)

The vegetation structure on both the Preferred and Alternative sites comprised grassland, dominated by the pioneer grasses *Cynodon dactylon*, *Eragrostis plana* and *E. curvula* (Photo plate 1 and 2). The grass species diversity, especially of palatable grasses such as *Digitaria eriantha* and *Themeda triandra*, was low and the hardy pioneer and perennial grasses (e.g., *Cynodon*, *Eragrostis*, *Chloris*), typical of rehabilitated grassland dominated. The forb diversity was also low and dominated by hardy species (*Conyza podocephala*, *Helichrysum rugulosa*, *Gazania krebsiana*, and *Felicia muricata*). Several weedy and invasive species were also recorded (*Verbena tenuisecta*, *Schkuhria pinnata*, *Tagetes minuta* and *Verbena bonariensis*).

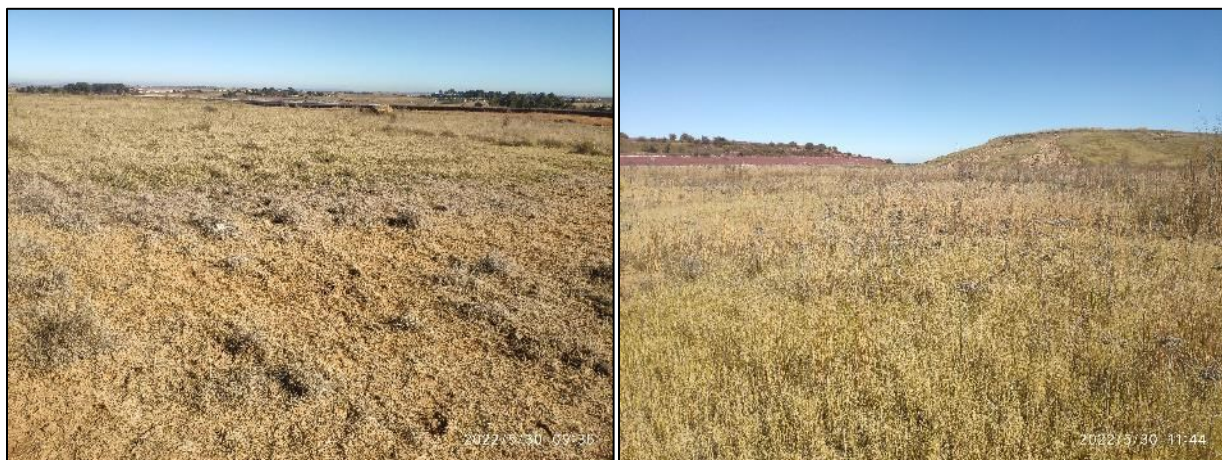
Photo plate 2: Secondary grassland on the alternative site on Prt 9 of the Farm Withok 131, taken during the May 2022 assessment

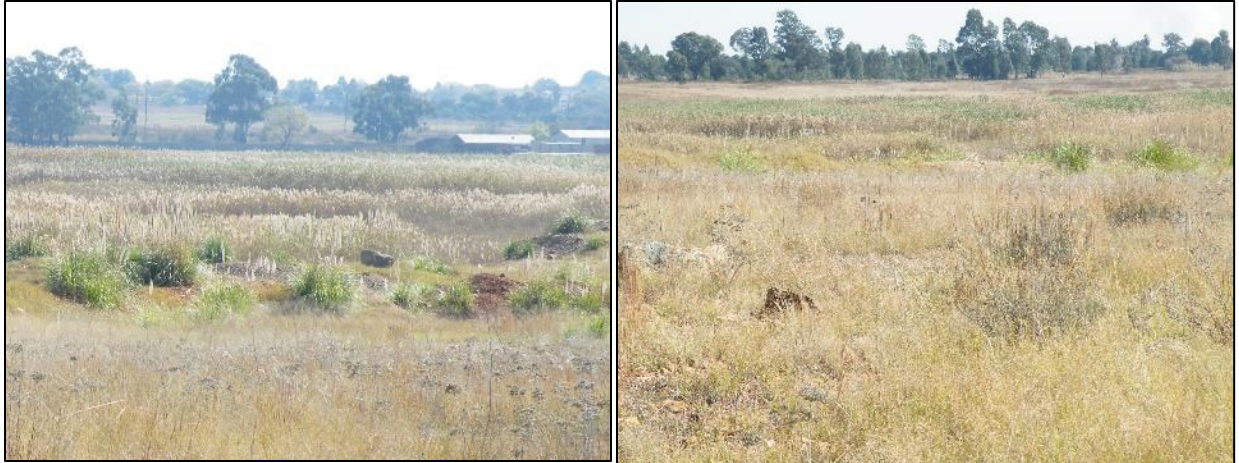
Photo plate 3: *Phragmites australis* moist grassland to the east and north of Prt 183 and 272 of Witpoortje 117

Most of the moist grasslands that could be impacted on are dominated by *Phragmites australis* (Photo plate 3). The tall growing grass *Phragmites* plays an important role in wetlands, particularly disturbed or impacted wetlands as it has an extensive root system that binds soils and prevent erosion. It can withstand high levels of environmental contamination and can assimilate heavy metals, nitrogen and phosphorous and can become the dominant grass in disturbed wetland areas (Tarr, 2006). The temporarily wet areas around the *P australis* were dominated by the grasses *Cynodon dactylon* and *Eragrostis plana*, with patchy occurrence of sedges such as *Juncus effusus* and *Cyperus congestus*.

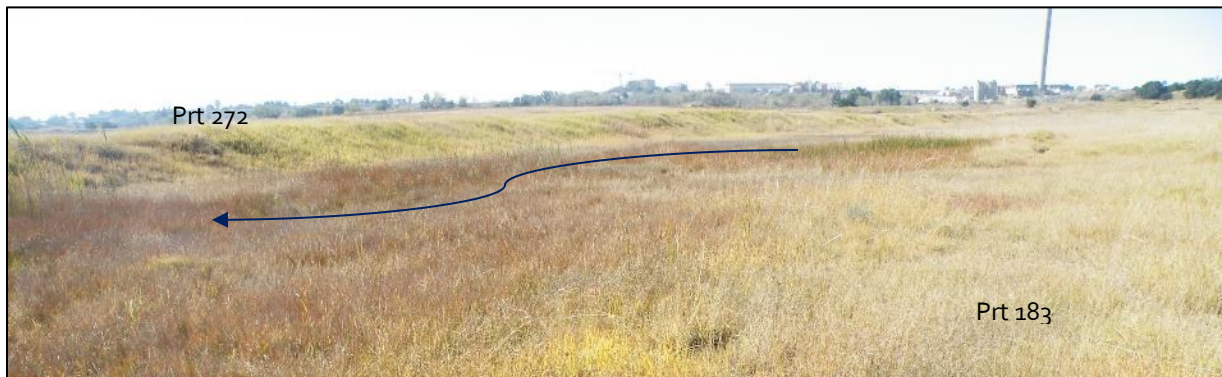
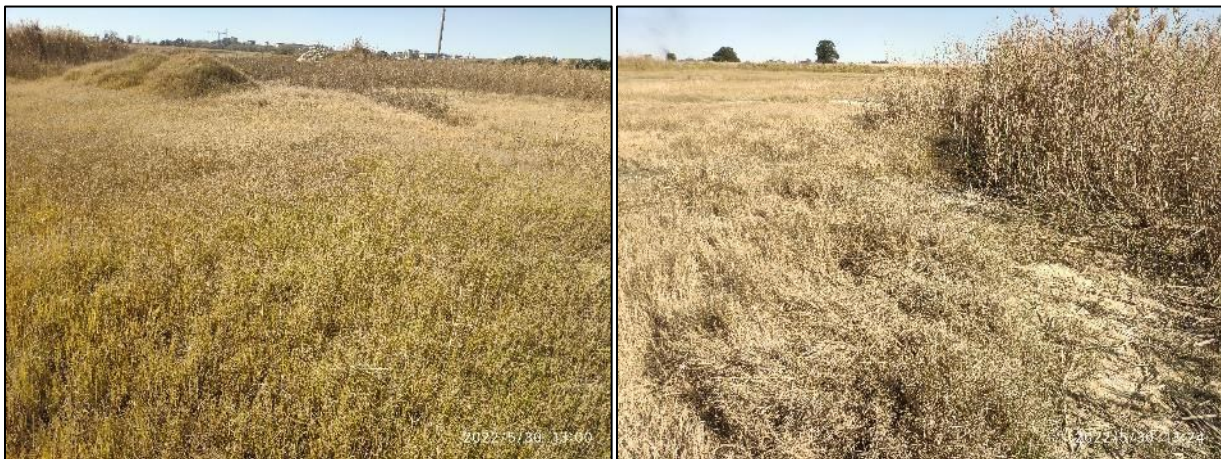
Photo plate 4: Highly disturbed moist grassland between Prt 183 and 272 of the farm Witpoortje 117 comprising a mosaic of dominant species

An area mapped as *Phragmites australis* moist grassland traverses the land between Prt 272 and Prt 183 of the Farm Witpoortje 1171R (Photo plate 4). This area is highly disturbed with patches of *P australis* embedded in a mosaic of moist grassland with other dominant species such as *Eragrostis plana*, *Paspalum dilatatum* and the invasive *Arundo donax*.

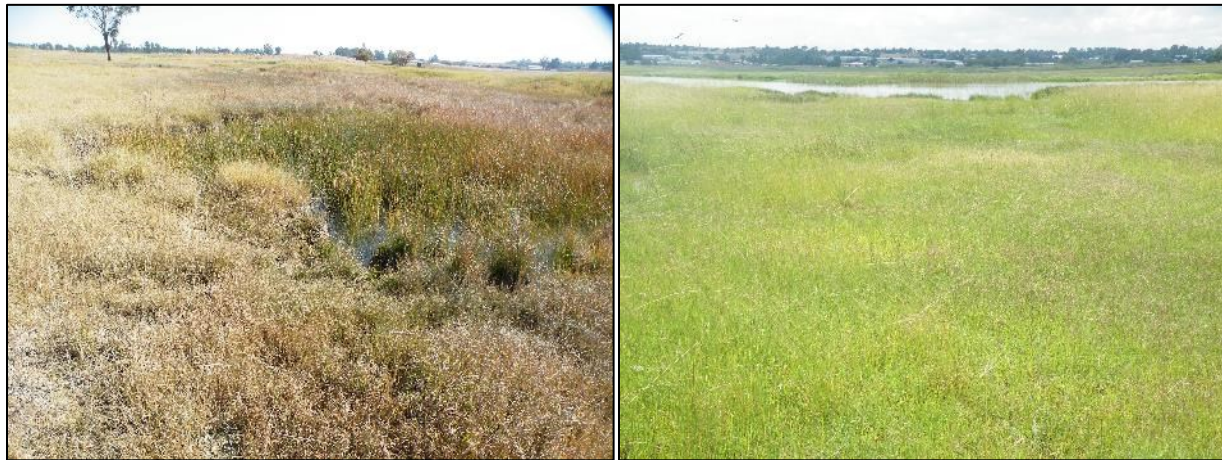
Photo plate 5: *E plana* dominated moist grassland

A small artificial dam and inundated grassland are present on Prt 183 of the farm Witpoortje (Photo plate 5). These are artificial wetlands (please refer to the wetland assessment for a definitive delineation of wetlands). The edges of the moist areas were dominated by *Cynodon dactylon* (couch grass) and *Eragrostis plana* (tough love grass). Sedges such as *Juncus effusus* and *Cyperus congestus* were recorded. No plant species of conservation concern were observed, and none are expected to be present due to the secondary nature of the vegetation.

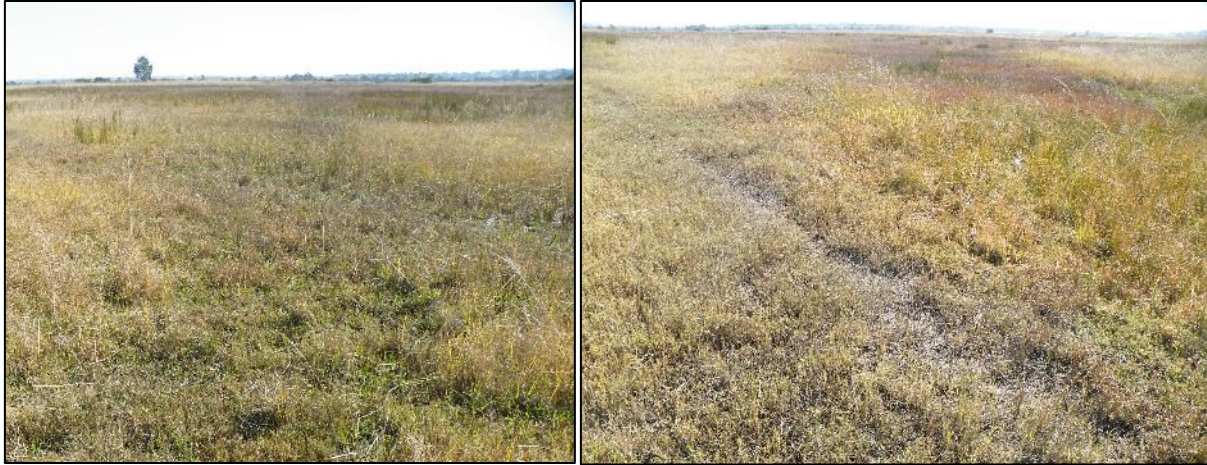
Photo plate 6: *Eragrostis plana* moist grassland to the east of Prt 9 of the Farm Withok (Alternative site)

Eragrostis plana moist grassland was also recorded to the east of Prt 9 of the farm Withok (Alternative site). This large area historically comprised a slimes dam and was rehabilitated. The area is grazed and included the grasses *Cynodon dactylon*, *Hyparrhenia hirta* and *Aristida congesta* (Photo plate 6)

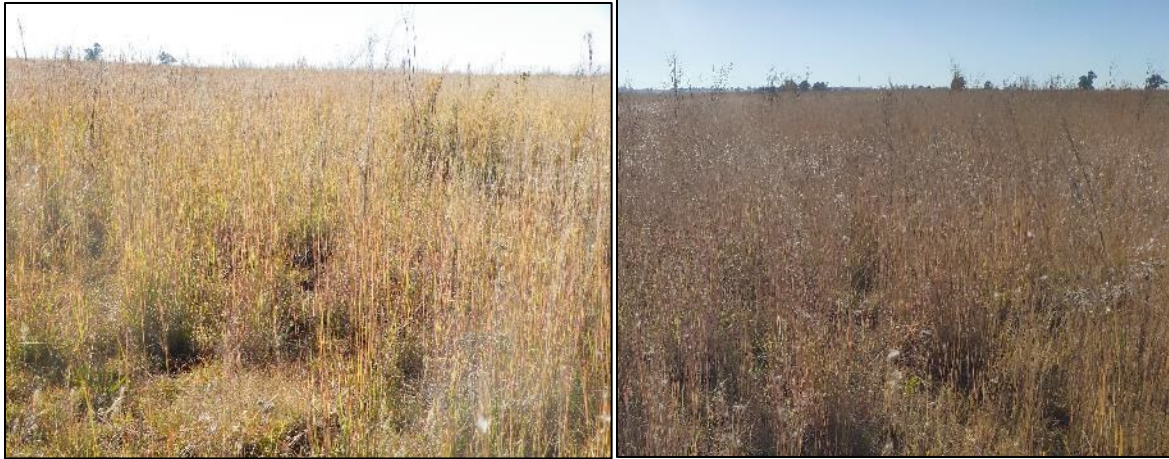
Photo plate 7: *Andropogon eucomis* moist depression

A moist depression formed within the rehabilitated areas on Prt 9 of the Farm Withok 131 (Alternative site). This area was dominated by the grass *Andropogon eucomus* (old man's beard) and *Imperata cylindrica* (cotton wool grass) (Photo plate 7). These grasses are good stabilisers of wet soils and indicative of poor drainage. Other grasses included *Eragrostis plana*, *E. gummiflua* (gum grass) and *Cynodon dactylon*. The forb layer included weedy species such as *Gomphocarpus fruticosus* and *Verbena bonariensis*. The invasive tree *Tamarix cf ramosissima* (pink tamarisk) also colonised this area.

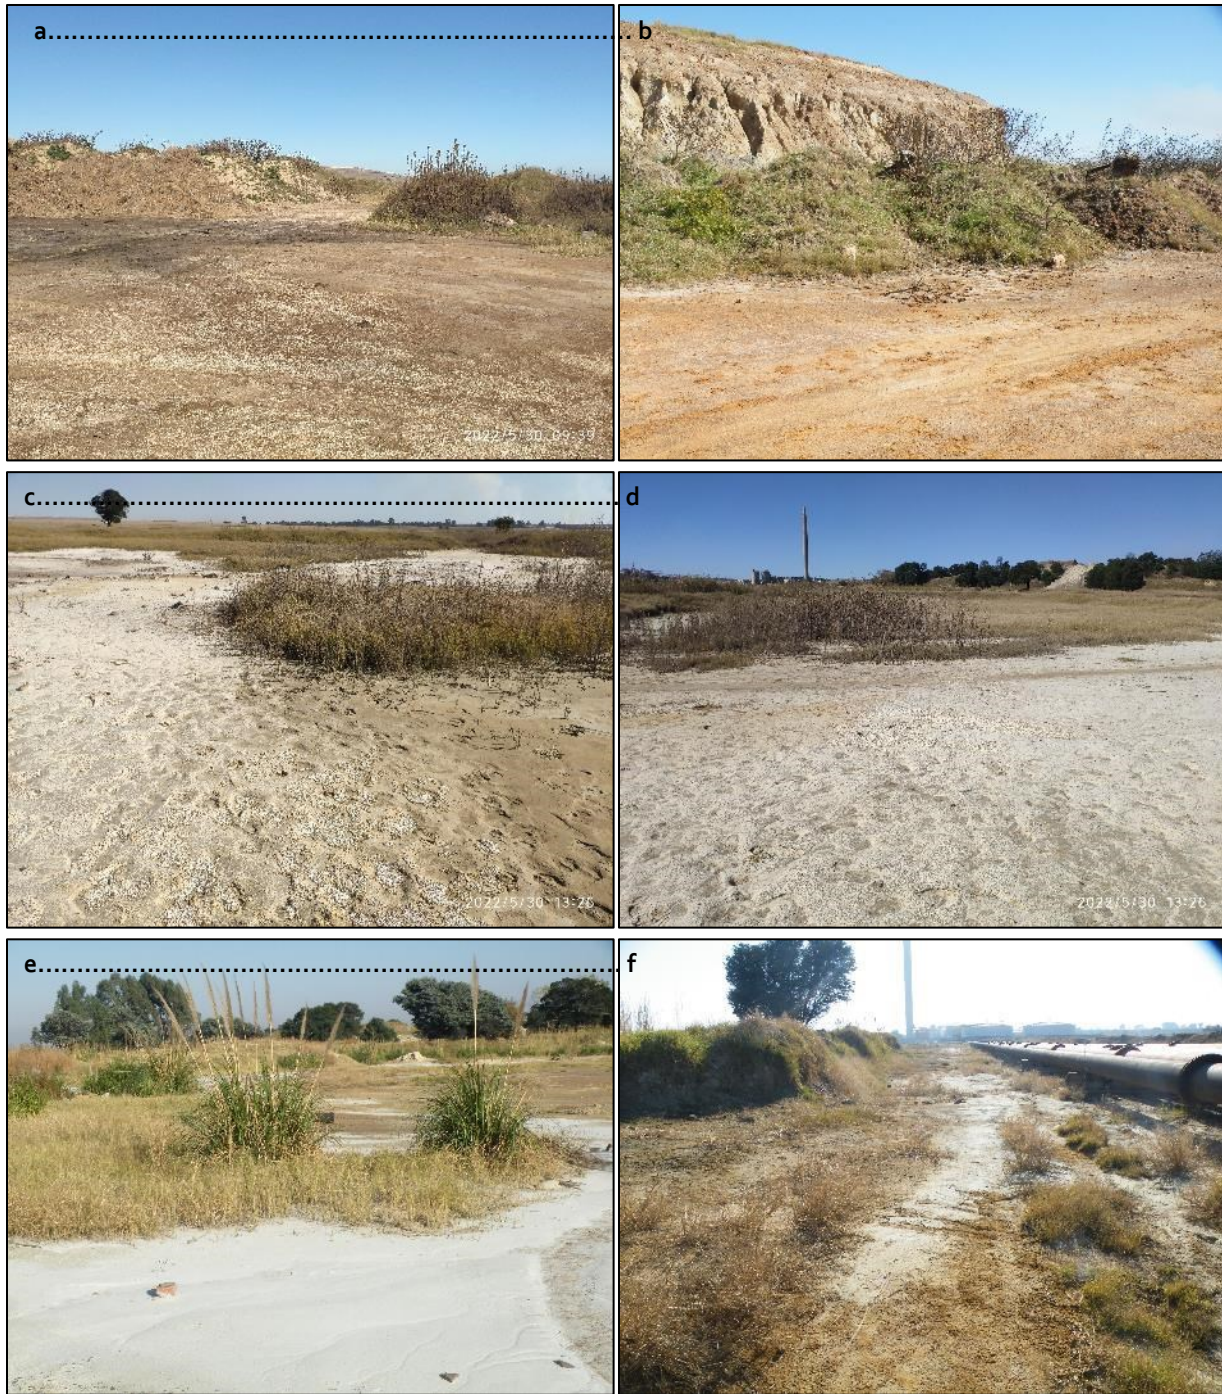
Photo plate 8: Modified land on a&b) Prt 9 of the Farm Withok (Alternative site), c-f) prt 183 of the Farm Witpoortje

Modified land comprises areas where the natural vegetation was destroyed or degraded beyond a threshold of recovery, or replaced by lawns, invasive species, or ongoing activities. The western and eastern extent of Prt 183 Witpoortje 117, as well as a portion of Prt 9 of the Farm Withok 131 (Alternative site) was modified. These areas included compacted soils, large soil dumps, illegal mining activities or remnant slimes dams (Photo plate 8). The vegetation was sparse and dominated by the pioneer grass *Cynodon dactylon*. The category 1b invasive *Cortaderia selloana* (fountain grass) and invasive tree species (e.g Wattle, Eucalyptus and Tamarix) were common. Artificial depressions supported the hydrophylic grass *Phragmites australis*.

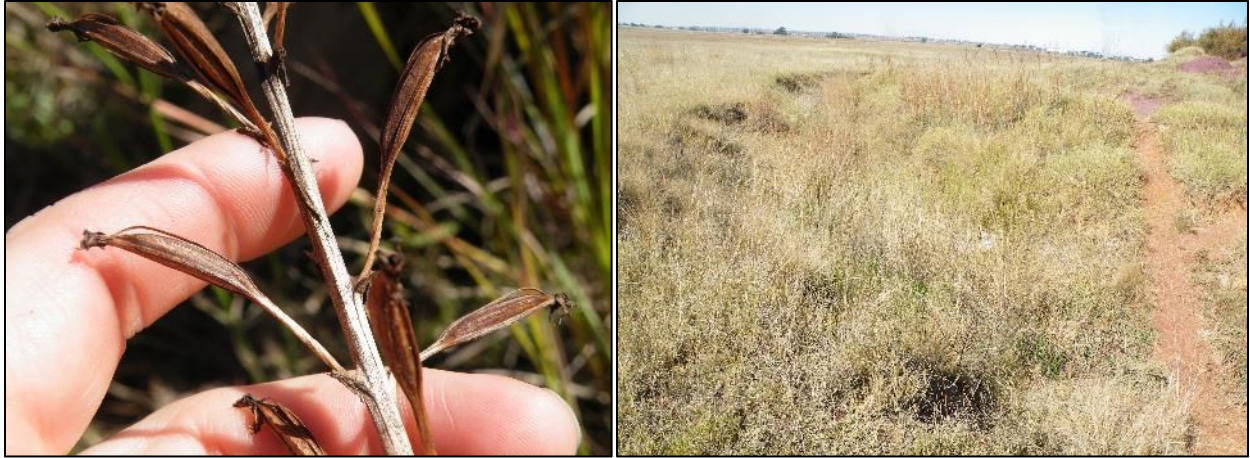
Photo plate 9: Orchid species recorded in the secondary grassland on Prt 9 of the Farm Withok (Alternative site)

One provincially protected species was recorded on Prt 9 of the Farm Withok (Alternative site) during the May 2022 field survey. The orchid species was already dry and the flowers dead (Photo plate 9). However, it is believed to be a *Habenaria* species, likely *Habenaria schimperiana*. *H schimperiana* was recorded during Phase 1 along the proposed powerline (Dimela Eco Consulting, 2022).

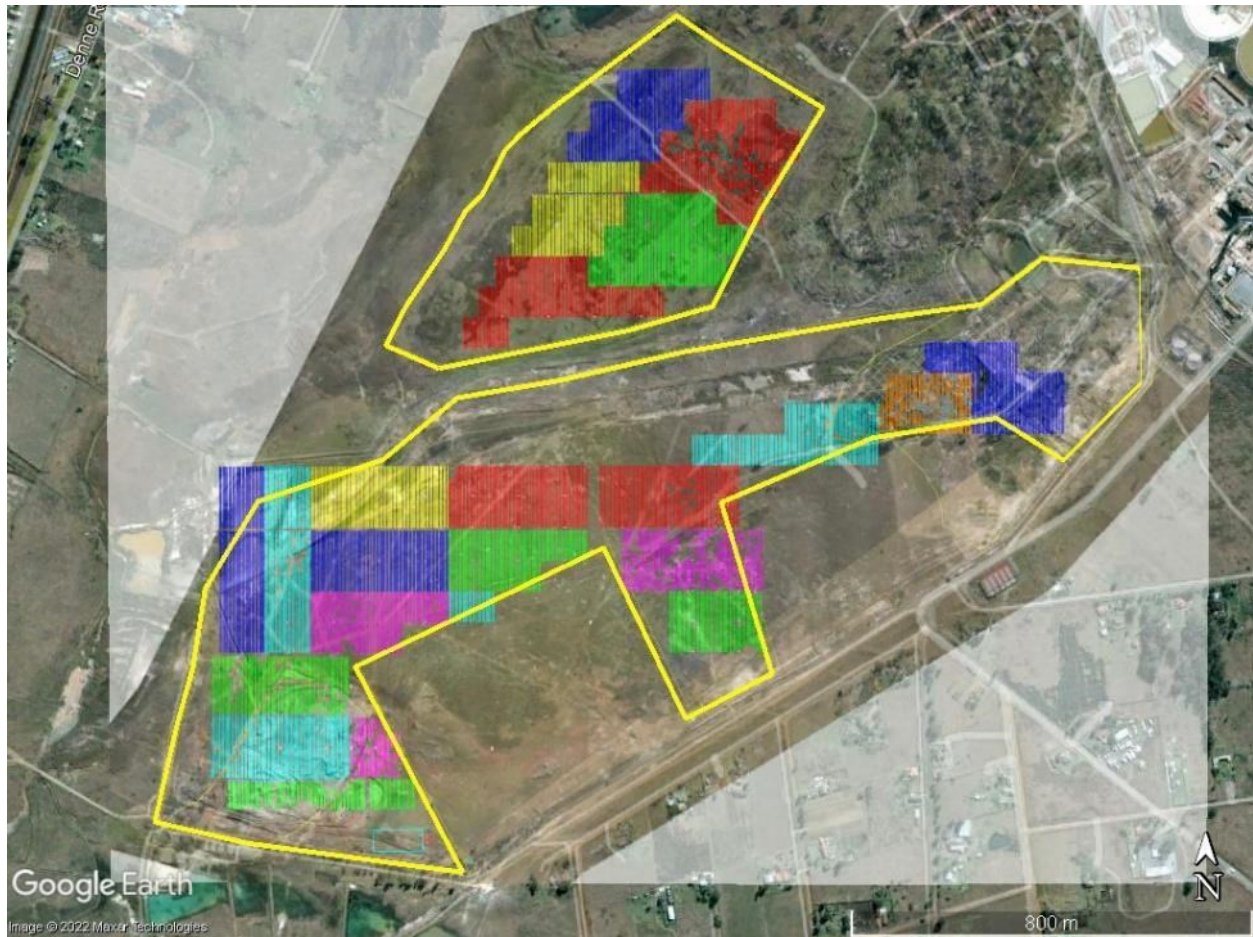
Figure 16: Estimation of the proposed panel layout on the Preferred site, overlaid onto Google Earth imagery. Note there is a data error of about 50m on the map, all panels will be developed within the site boundary

Figure 16 shows the proposed panel layout on the Preferred sites. The panel layout respects the flow of the Withokspruit, however, the artificial dam area (*Eragrostis plana* moist grassland) on Prt 183 of the Farm Witpoortje, will be destroyed. Table 11 compares the impacts on sensitive features between the Preferred and Alternative site.

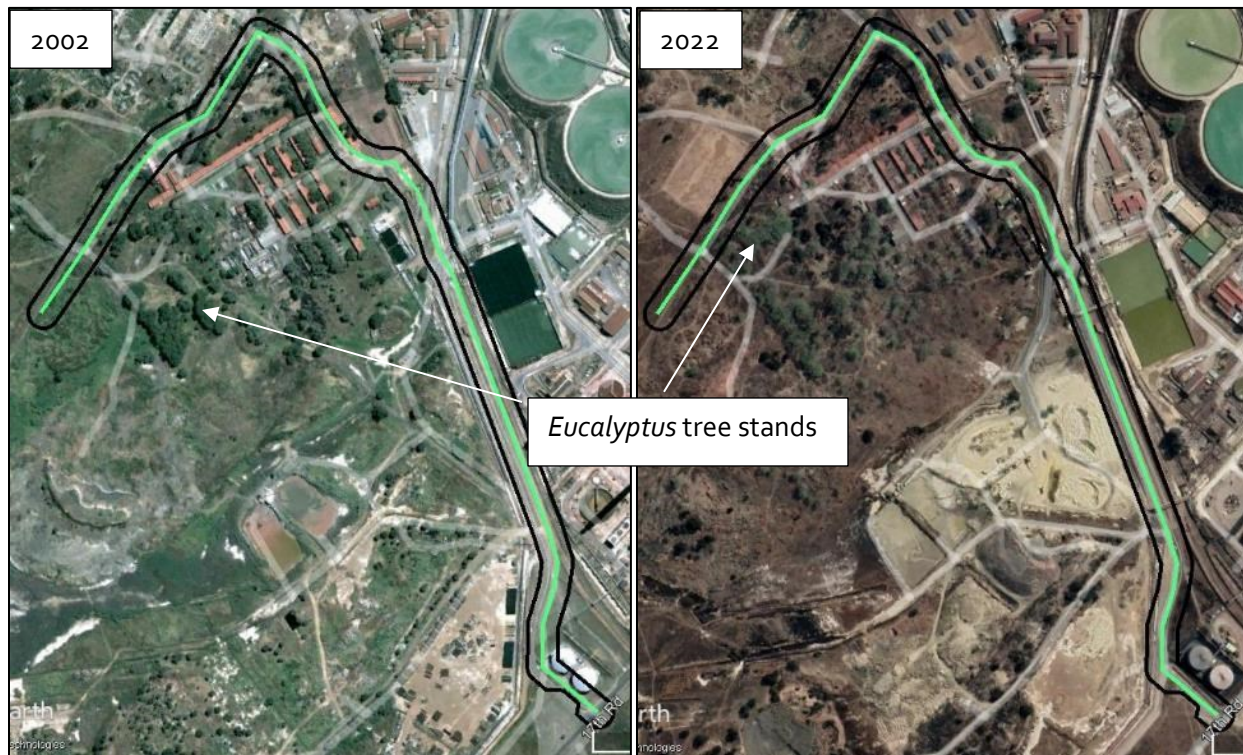
Figure 17: Google Earth satellite imagery of the additional access road in the years 2002 and 2022 showing the largely modified state of the vegetation along the road and within a 20m buffer thereof

The additional road proposed to access Portion 272 of the Farm Witpoortje 117 was not sampled, however, Google Earth Satellite imagery and photographs received from the client, indicated that most of the vegetation along the proposed road were also modified (Figure 17). The road comprises an existing tar road in the south and an existing dirt road in the north. The vegetation includes stands of *Eucalyptus*

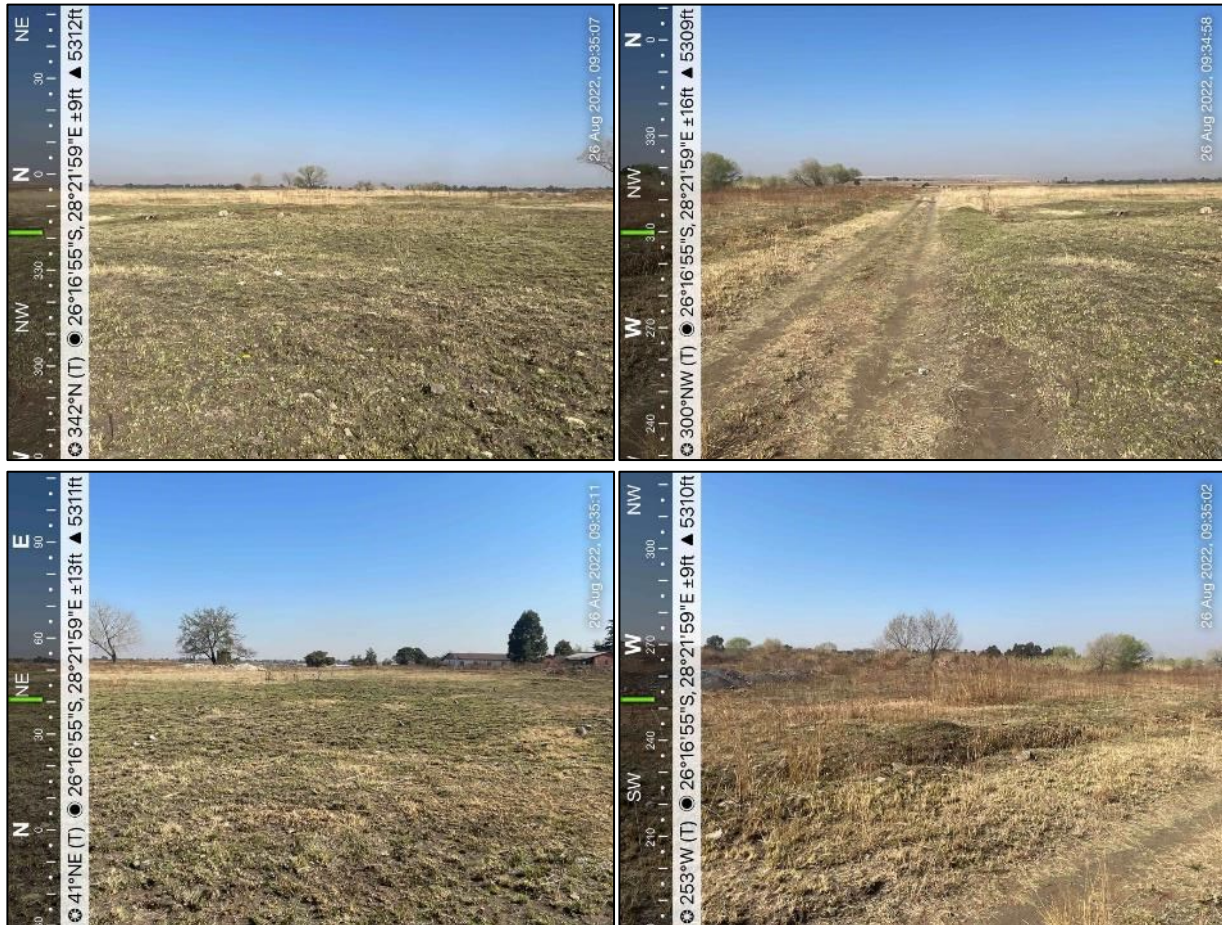
Photo plate 10: Images of the secondary and historically disturbed land along the northern extent of the additional access road

The road may impact on some secondary grassland as it enters the PV block (Photo plate 10). Satellite imagery suggest that the vegetation was impacted on historically as it is adjacent to a sports field and historically cultivated land. It is highly unlikely that plant species of conservation concern are present in this area and therefore this report does not object to the utilisation of this existing road.
