# EMP audit report

Dec 2021

**Project:** BCR/21/01  
**Report:** BCR/21/01/01  
**Operation:** BCR Minerals (Pty) Ltd. -  
Spitsvale

## BCR Minerals (Pty) Ltd – Spitsvale: EMP audit

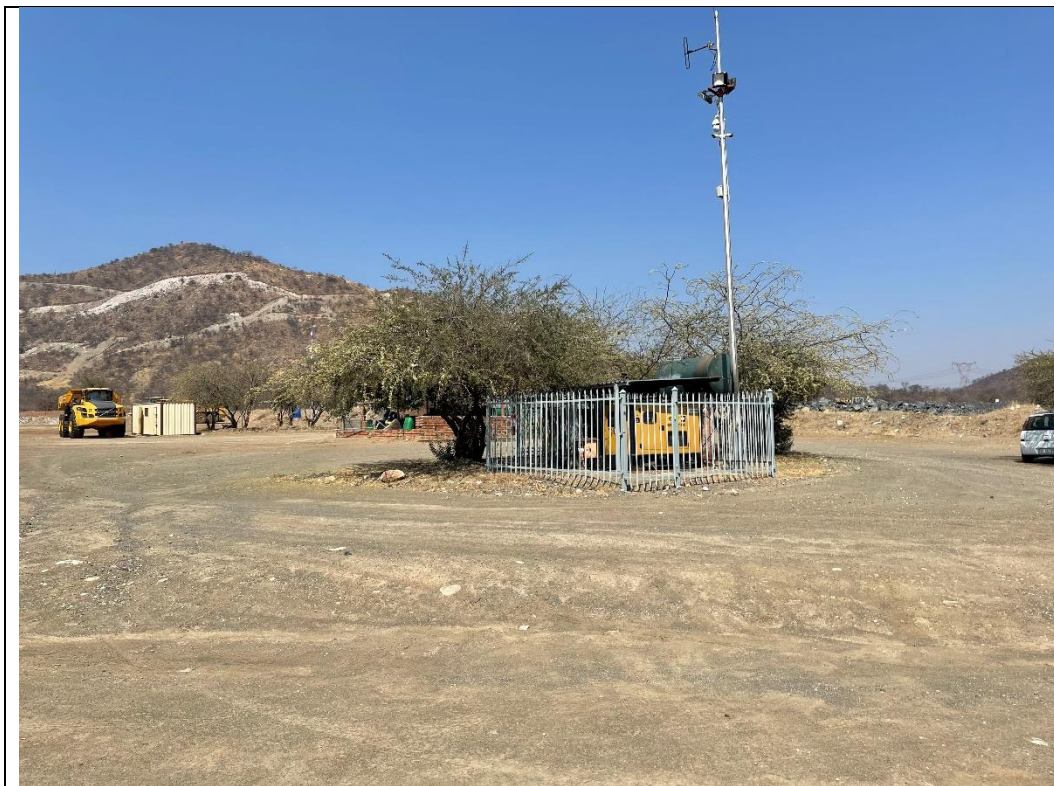
**Photo 1**

**Area:** Office area

**Observations:** This photo is of the generator fuel tank and electrical generator. No berms around the generator or fuel tank. Area generally kept clear of spills.

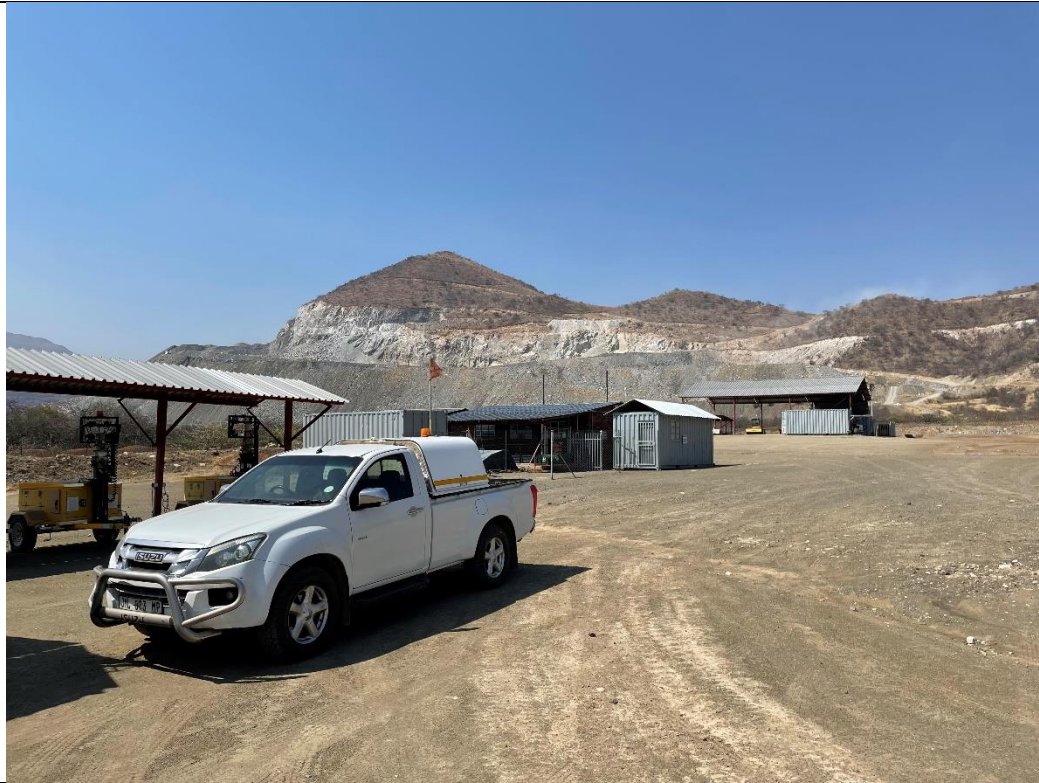
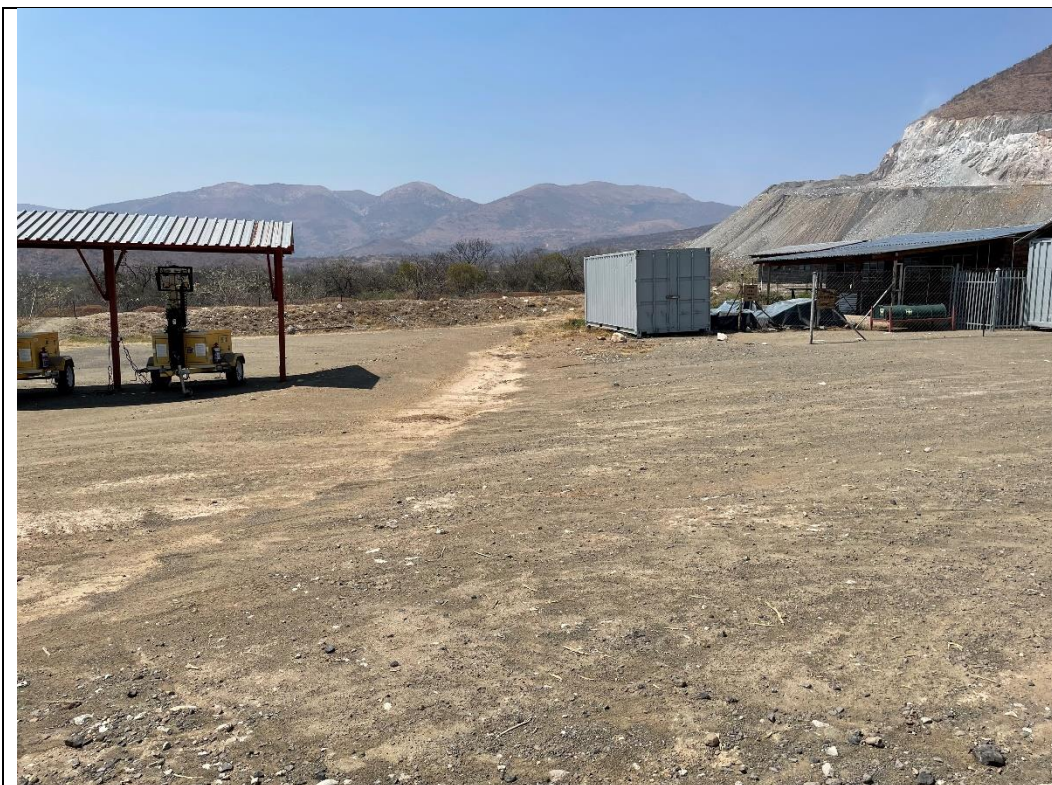
**Photo 2 & 3**

**Area:** Workshops

**Observations:** Informal storm water channel observed. Discharge point of the channel flows in to the surrounding natural environment. No signs of silt retention measures observed.

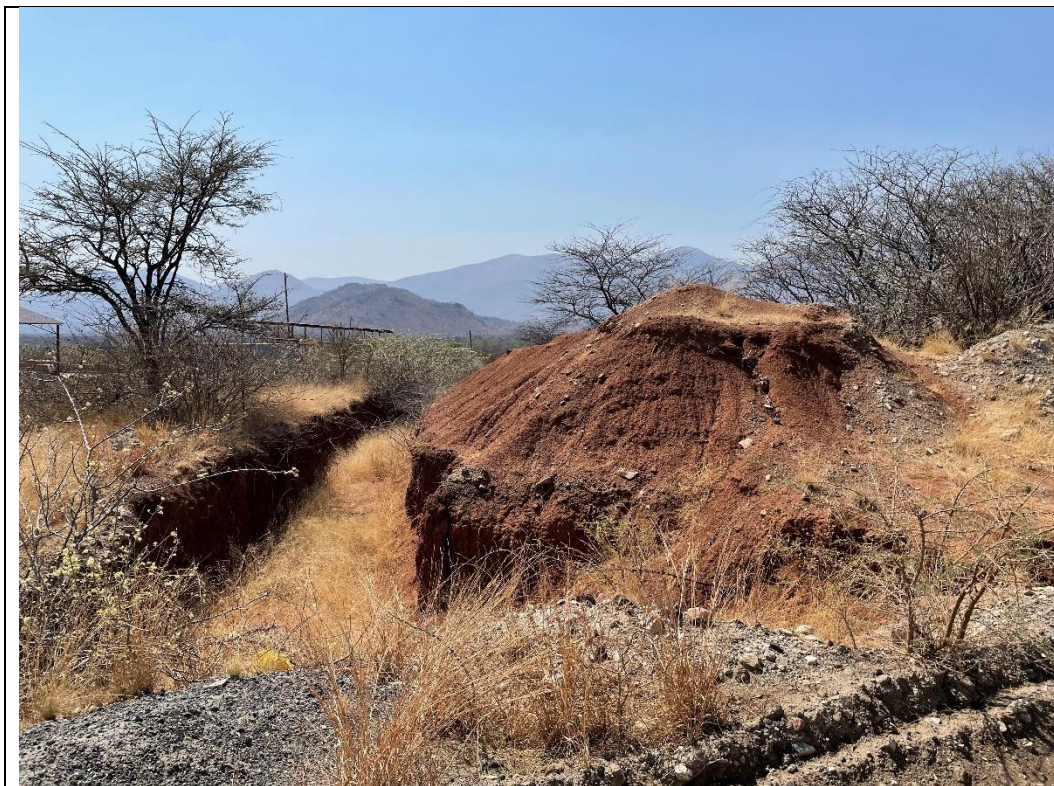
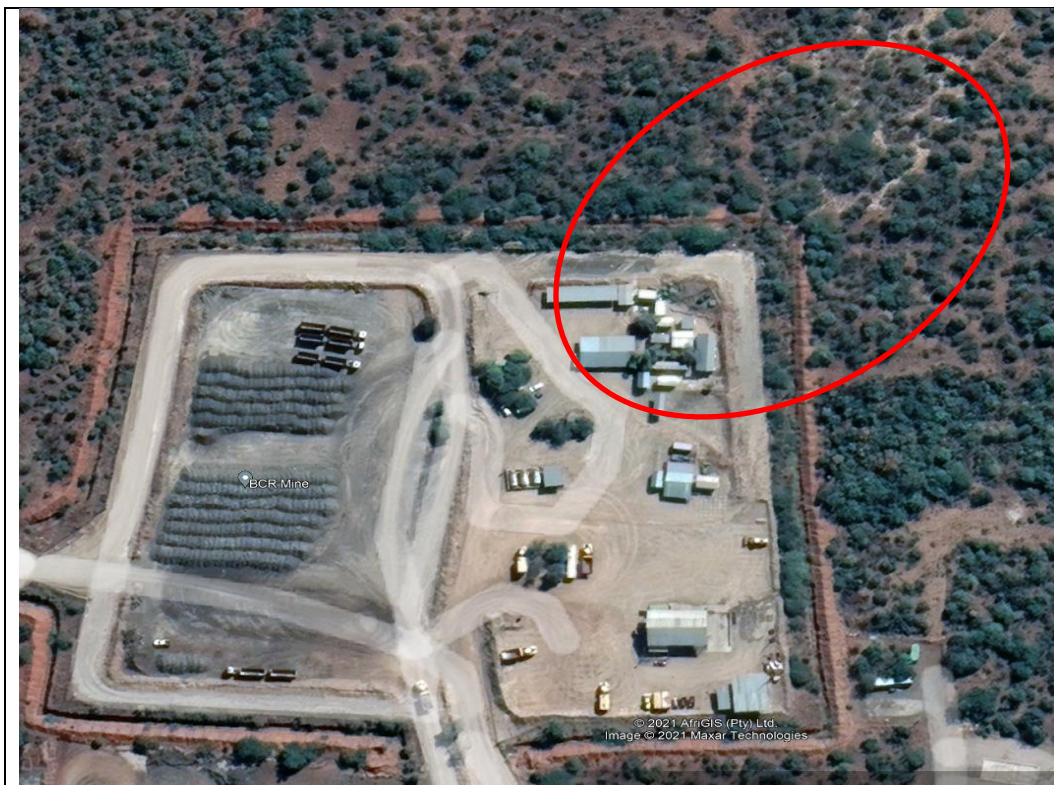
**Photo 4**

**Area:** Storm water channel and diversion berm

**Observations:** This photo is of the storm water trench and diversion berm. Erosion is visible on the diversion berm, which also serve as the topsoil stockpile. This channel collects the water from the informal storm water channels flowing from the offices and workshop areas (see photo 2). From google there is evidence that there have been discharges into the natural environment at the north-east corner of the channel (visible sediment observed).

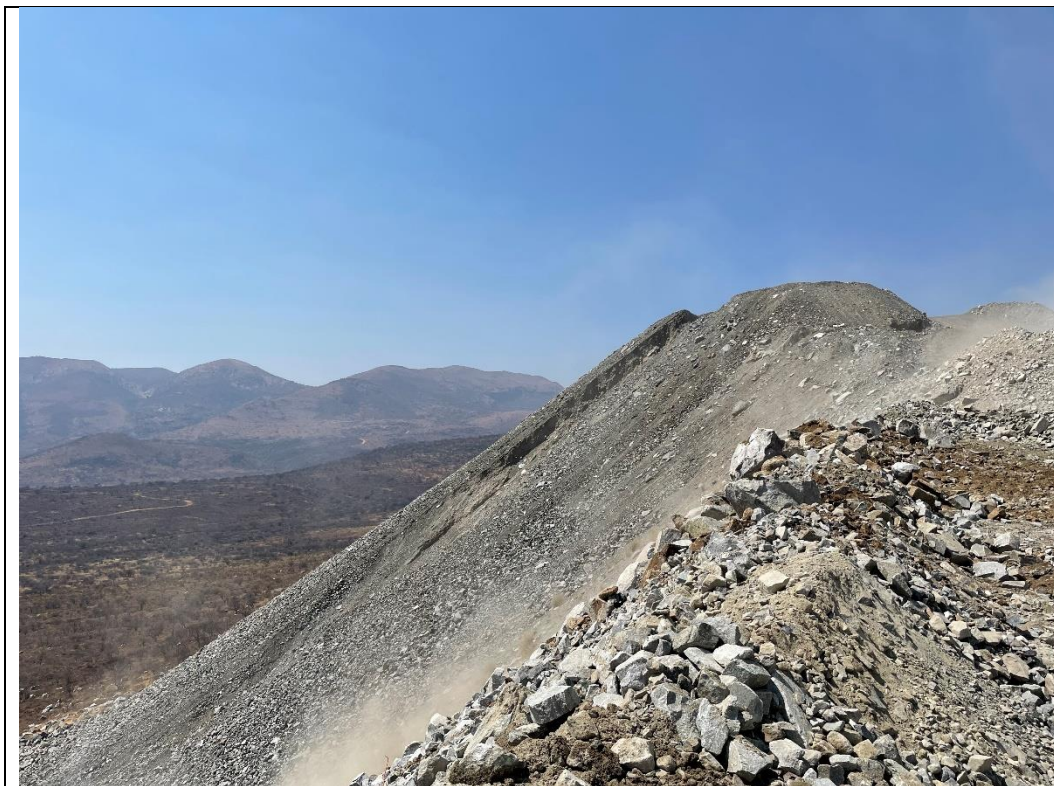
**Photo 6**

**Area:** Waste Rock Stockpiles (Overburden)

**Observations:** This photo is of the erosion formation observed on the Waste Rock Stockpiles (overburden) on the sides of the mining pit. Also see Photo 7.

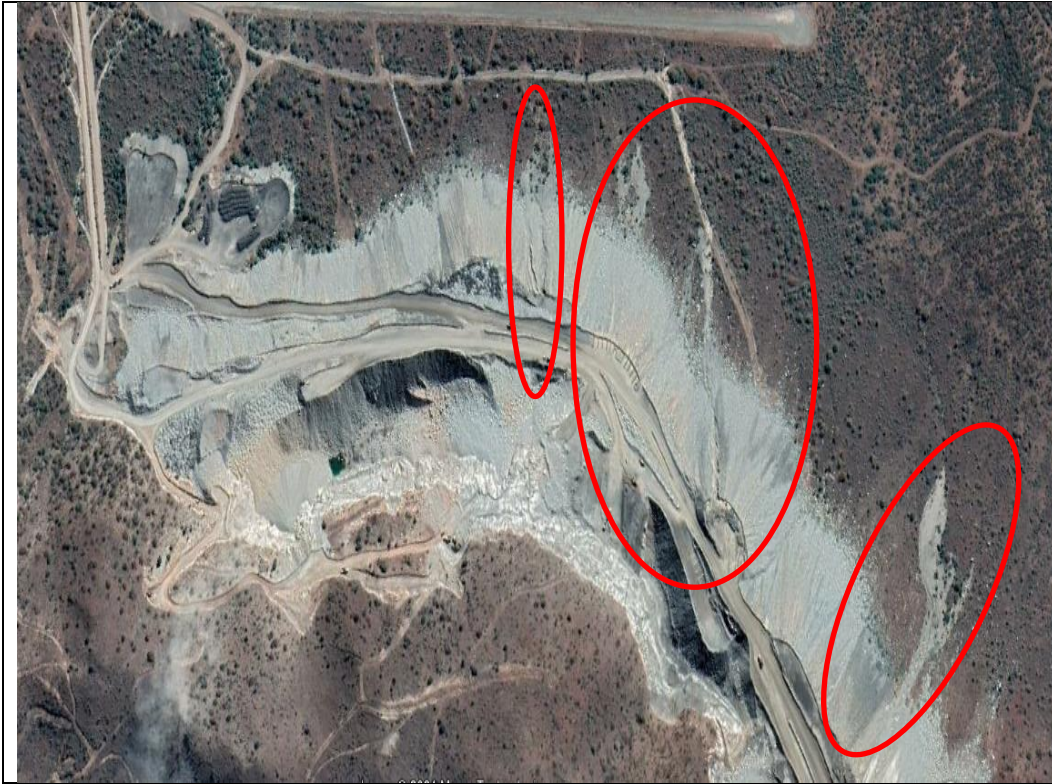
**Photo 7**

**Area:** Waste Rock Stockpiles (Overburden)

**Observations:** This photo is a areal google image of various affected streams as identified by the EIR and EMPr. There are visible signs of erosion formation and sedimentation into the natural environment.

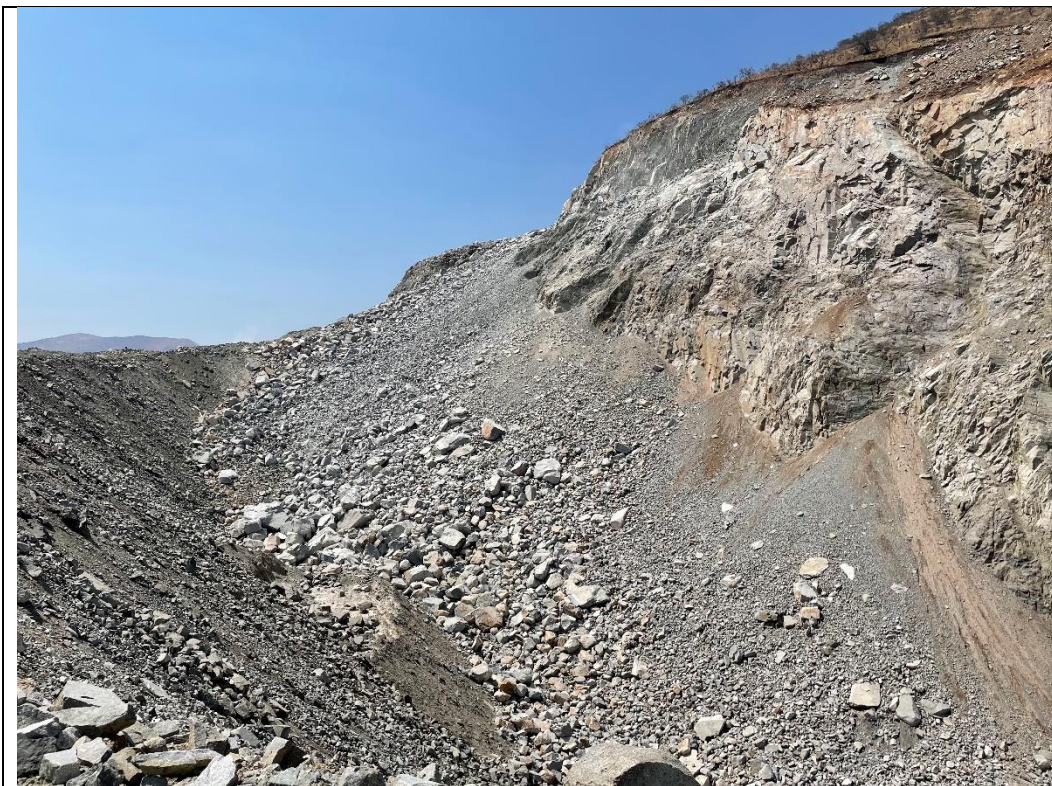
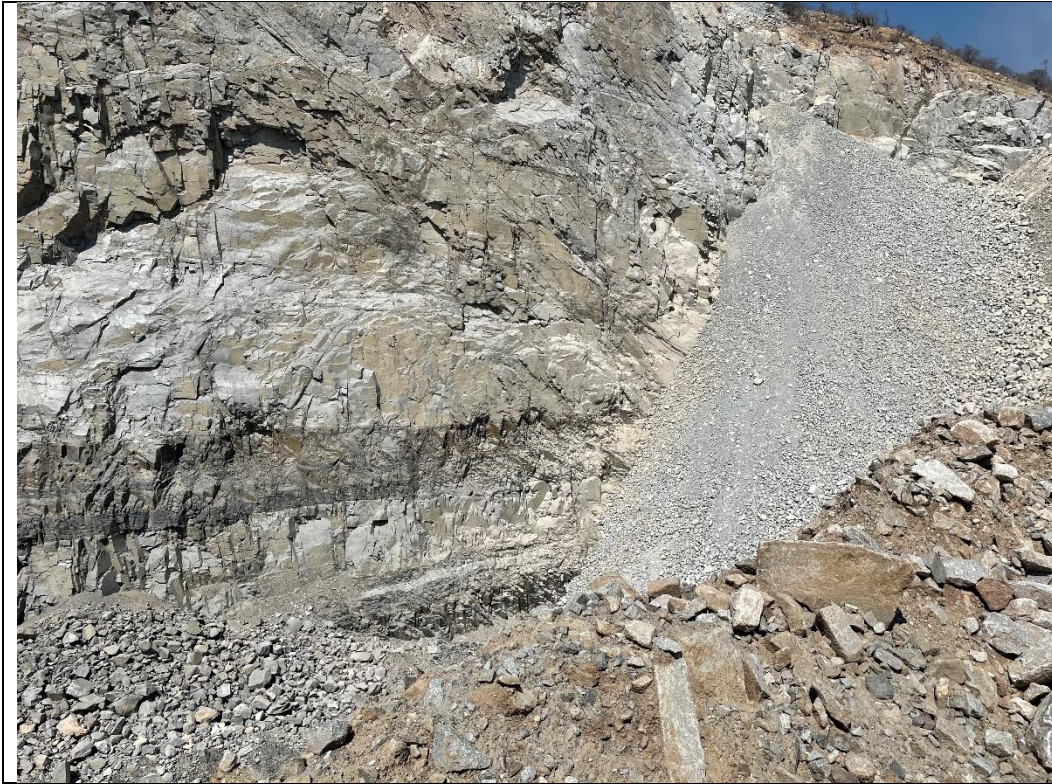
**Photo 8 & 9**

**Area:** Mining pit

**Observations:** Backfilling of previously mined pit.

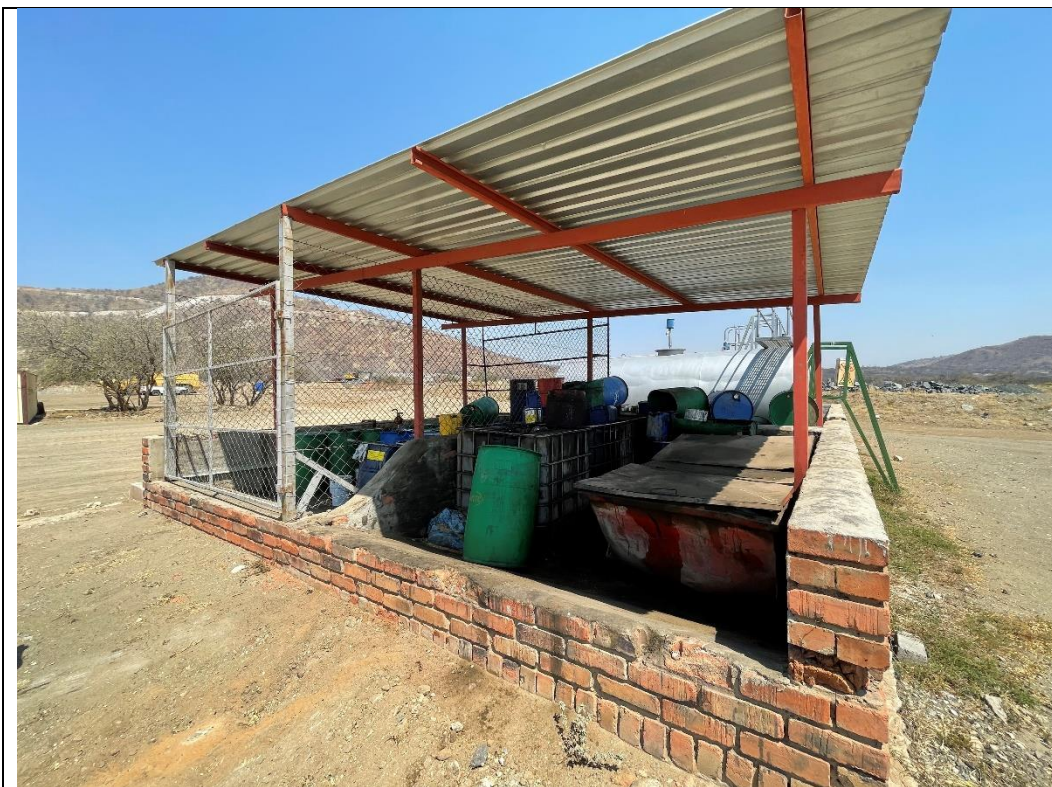
**Photo 10**

**Area:** Hazardous chemical store

**Observations:** This photo is of the hazardous chemical store. The store is well ventilated and has a roof. The oil store is locked. The hazardous waste bin can be observed in the photo on the right of the hazardous chemical store.

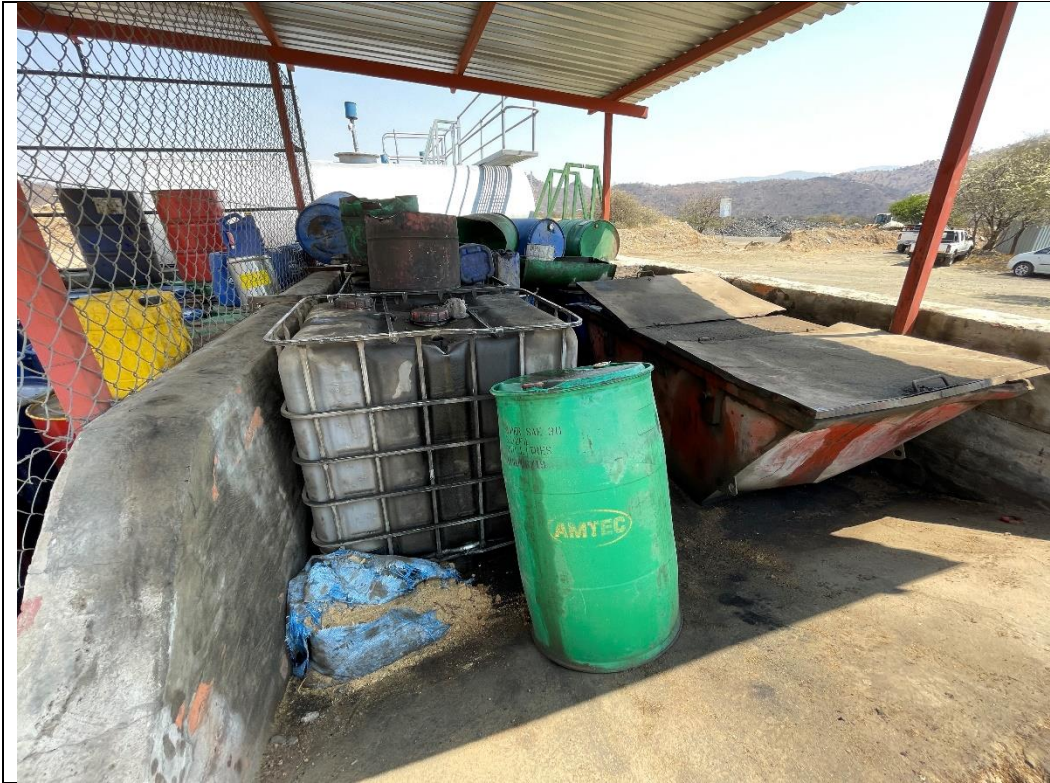
**Photo 11**

**Area:** Hazardous chemical stores

**Observations:** This photo is of the hazardous chemical stores area. It can be observed that the containers are not labelled. Spillages are visible but treated with absorbent. The absorbent were not yet removed to the hazardous waste bin.

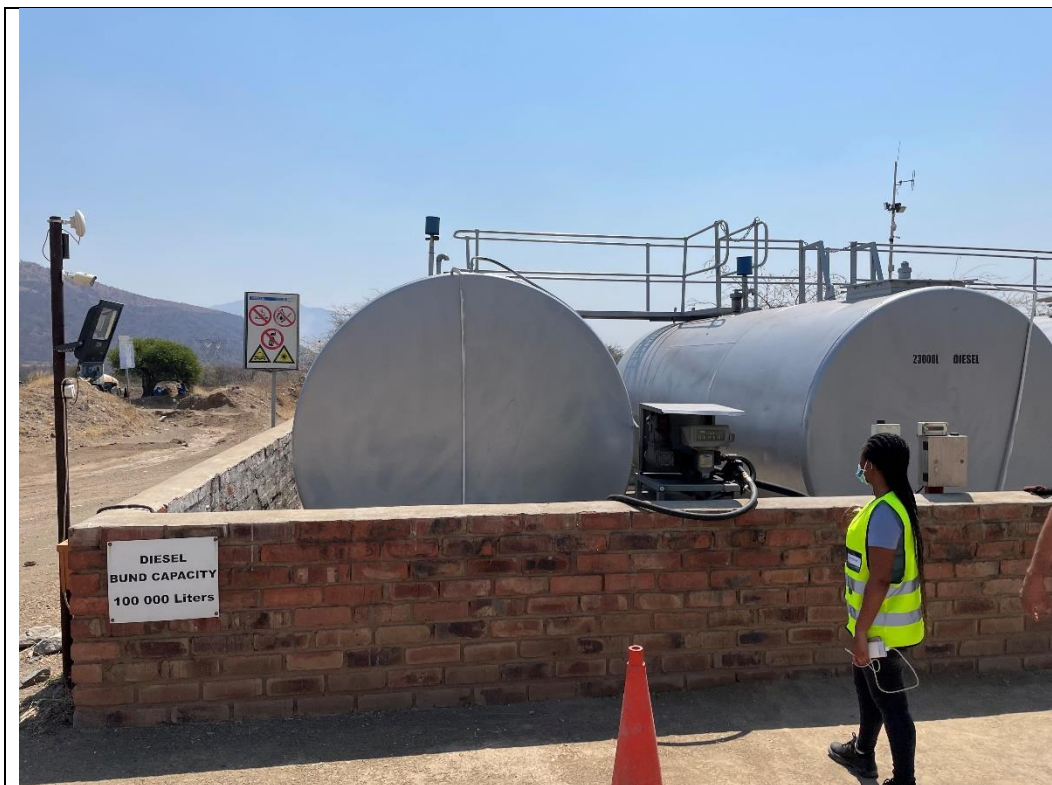
**Photo 12**

**Area:** Fuel tanks

**Observations:** This photo is of the main fuel tanks. Bund wall with capacity display is observed.
